Manhole Inspection Summary

Manhole # S29K__065MH

Insp Date: **1/30/09 10:58 AM**

Location Address: **762 Otterbein St.**

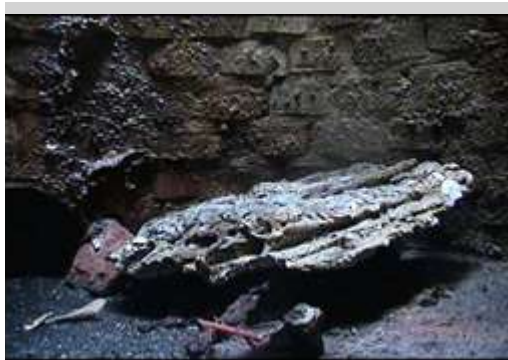
Misc

debris at base

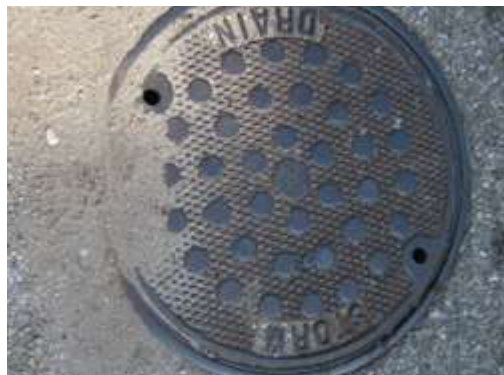
MISC

wrong cover- manhole has storm drain cover

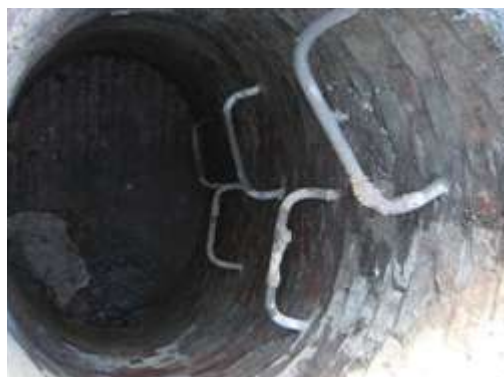
Defect 3

Infiltration: ☐ None ☐ Joint ☐ Cracks ☐ Mortar ☐ Roots ☒ **Wall**

Count: **5** Missing: **0** ☒ **Corroded**

steps corroded corbel infiltration

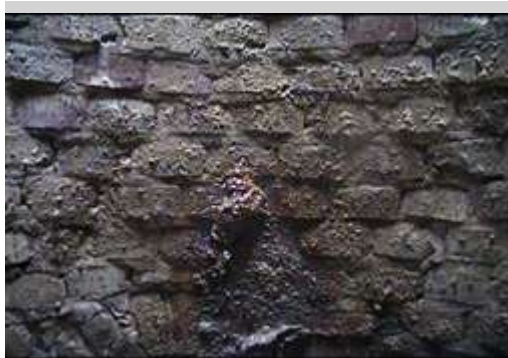
Defect 2

Infiltration: ☐ None ☐ Joint ☐ Cracks ☒ **Mortar** ☐ Roots ☒ **Wall**

barrel infiltration

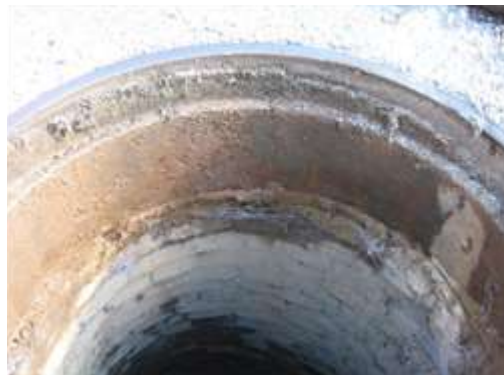
Defect 1

Condition: ☐ Sound ☐ Cracked ☒ **Leaks**

Infiltration: ☐ None ☐ Joint ☐ Cracks ☒ **Mortar** ☐ Roots ☐ Wall

frame &chimney infiltration
